FRACTURE OF HIGHLY CROSSLINKED UHMWPE ACETABULAR LINERS

J Furmanski*, SA Atwood*, BS Bal*, MR Anderson*, BL Penenberg*,
DK Halley*, AS Greenwald*, LA Pruitt** and MD Ries*

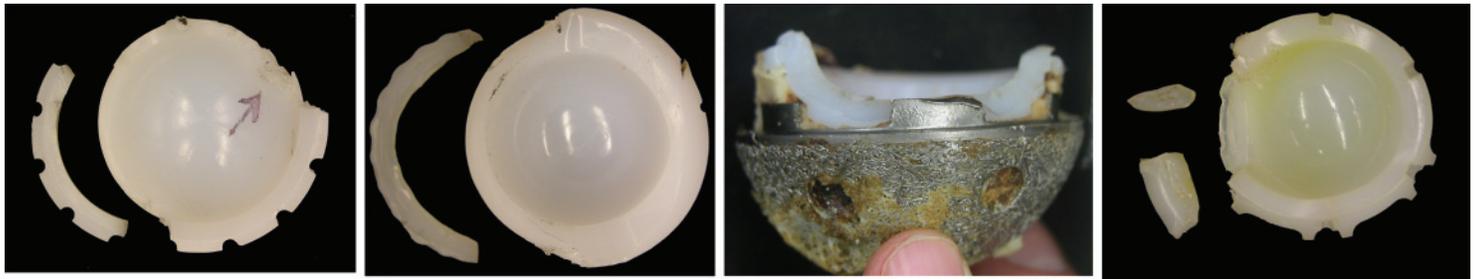
Figure 1. Cases 1-4, respectively. The liner in all four cases experienced a catastrophic fracture of the rim, originating at a stress concentration. Case statistics are listed in Tables 1-5.

Four well-placed crosslinked UHMWPE acetabular liners of distinct design were retrieved subsequent to fracture failure of the rim (Fig. 1). In each case, electron microscopy of the fracture surface (fractography) revealed fatigue initiation markings associated with a stress concentrating feature in the rim (see below). Fracture surface investigation demonstrated that crack propagation in all cases followed contours of tensile stresses (as shown on facing page in Figure 11). FEA simulations were performed to examine whether direct rim loading, e.g., femoral neck impingement, could be the cause of the observed failures.

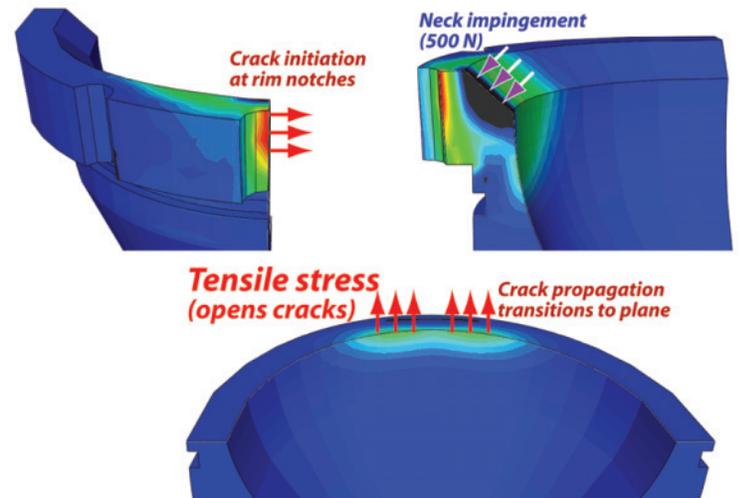
The simulations of each case show a crescent-shaped region of tensile stress surrounding the region of contact. In all cases, the magnitude of the maximum principal stress reaches its peak on the outer surface of the rim, at the root of a notch. Figure 2 schematically shows the orientation of the tensile stress for Case 1, which is in agreement with the crack opening direction in the retrieved liners. See below for more case details. All implants were free of significant oxidation.

Figure 2. Max. tensile stress due to impingement. Red arrows show orientation of stress and thus predicted crack opening direction. These predictions match the observed crack paths and orientations.

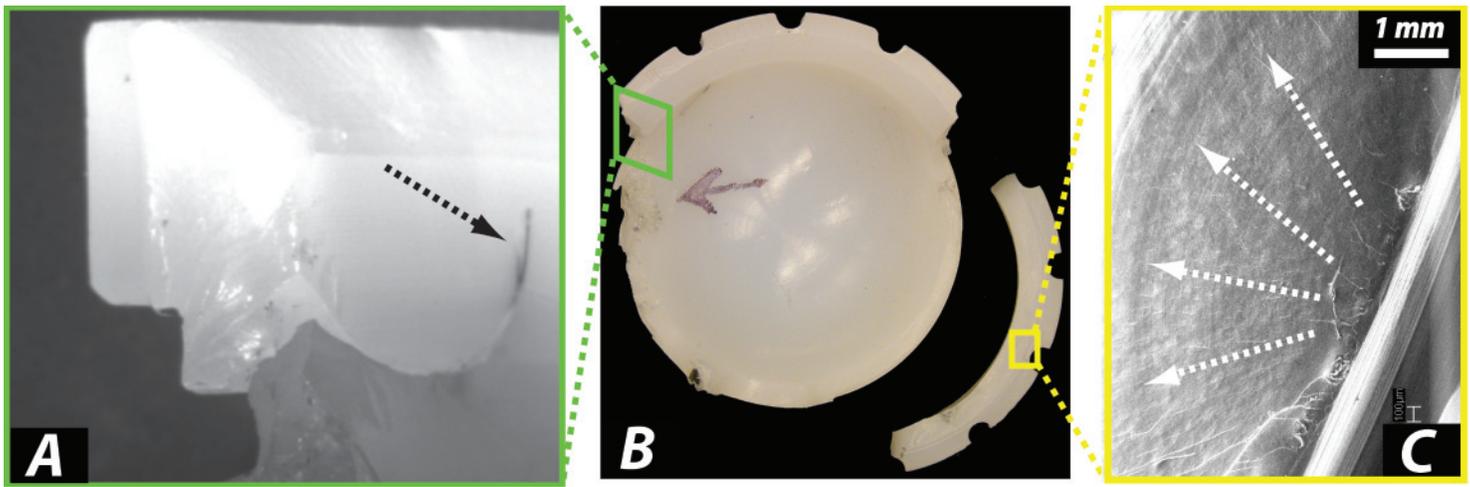
Figure 3. Fracture initiated on the underside of the rim, as shown by the procession of clamshell markings (3C). Cracks propagated in a crescent path (3A) and likely also initiated at the root of the rim notch. Multiple fractures initiated in this case, and a large arrested crack is indicated by the arrow in 3A. The crack also joins with the locking ring groove under the rim.

Case history A 62-year-old female with a BMI of 30 underwent uncomplicated primary total hip arthroplasty for osteoarthritis with a 52 mm Trilogy acetabular component and 36 mm Longevity acetabular liner (Zimmer, Warsaw, IN). Vertical inclination of the cup was 40 degrees and anteversion, measured by the method of Ackland et al. [5] was 45 degrees. She returned for routine follow-up one year after surgery and reported pain and “noises” in her hip. Radiographs demonstrated eccentric position of the femoral head in the acetabulum consistent with liner dissociation. Revision of the acetabular component was performed. Both the femoral component and acetabular shell were well fixed. The liner was found to be fractured along the rim and dissociated from the metal shell (Figure 3).

Findings The predicted maximum value of the principal stress in this case was 17 MPa, occurring at the root of the rim notch. The rim was modeled in contact with the metal backing, thus developing substantial tensile stresses (10 MPa) on the underside of the rim. Cracks likely initiated at both locations, while clamshell markings (initiation artifacts) are seen in the latter in Figure 3C. Cracks propagated between the rim notches following the tensile stress contours, which are crescent shaped. The cracks also linked with the circumferential groove in the implant, as seen in Figure 3A. Figure 3A also shows a large arrested crack in the rim. Intact components may harbor large arrested cracks, such as seen here, recommending the routine inspection of intact explanted liners. Such cracked implants may be on the verge of fracture and more data is needed on how pervasive arrested or nascent cracks are.

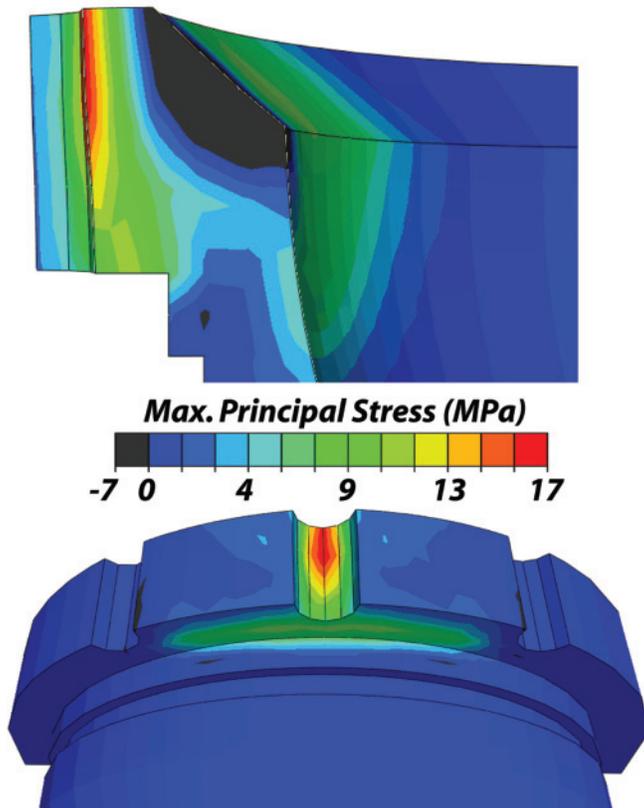
Figure 4. Tensile stress is maximum at the root of the notch and is substantial through a large portion of the thickness of the rim (Figure 4A). Note that 4A is the same cross-section and orientation as the fracture surface shown above in Figure 3A. Tensile stress under the rim is also severe enough to propagate cracks, and Figure 3C shows initiation markings at this location.

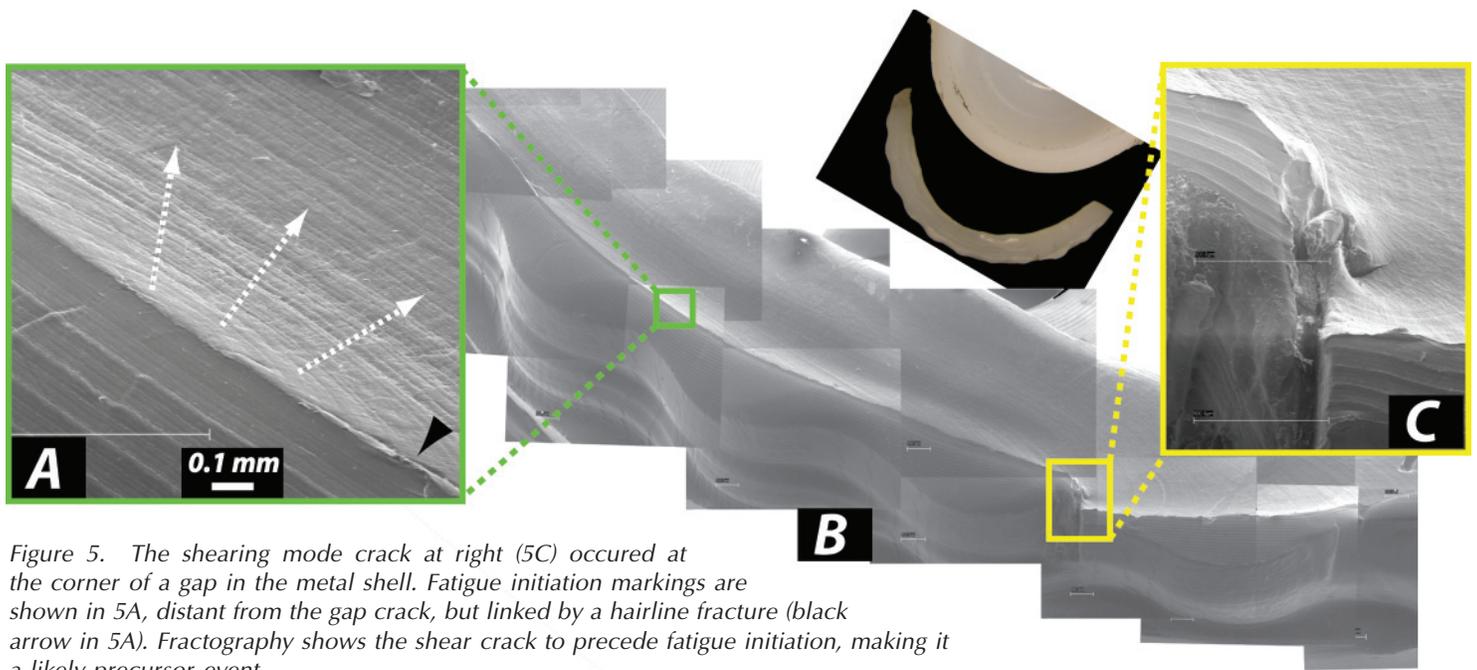
Figure 5. The shearing mode crack at right (5C) occurred at the corner of a gap in the metal shell. Fatigue initiation markings are shown in 5A, distant from the gap crack, but linked by a hairline fracture (black arrow in 5A). Fractography shows the shear crack to precede fatigue initiation, making it a likely precursor event.

Findings This design appears to have largely mitigated stress concentrations. However, there is a gap in the metal counterpart to the spline below the rim leaving it unsupported in that segment, resulting in a stress concentration at the two corners of the gap. The simulation shows tensile stresses exceeding 23 MPa at these locations, matching observed cracks in the spline (Figure 5C). The fractography shows fatigue initiation occurring remote from and subsequent to the spline gap fracture (Figure 5A). These two fracture features are linked by a hairline fracture, and thus the gap fracture is likely a precursor to the observed fatigue initiation. Recall that the results of Case 1 (Figure 4) demonstrated how tensile stress can develop on the underside of the rim, leading to crack propagation there. This simulation case also applies a 0.5 mm radial inward displacement to the spline to simulate an assembly press-fit. This develops the tensile stress seen on the inner surface of the liner and appears necessary to predict the failure, unlike in the other three cases.

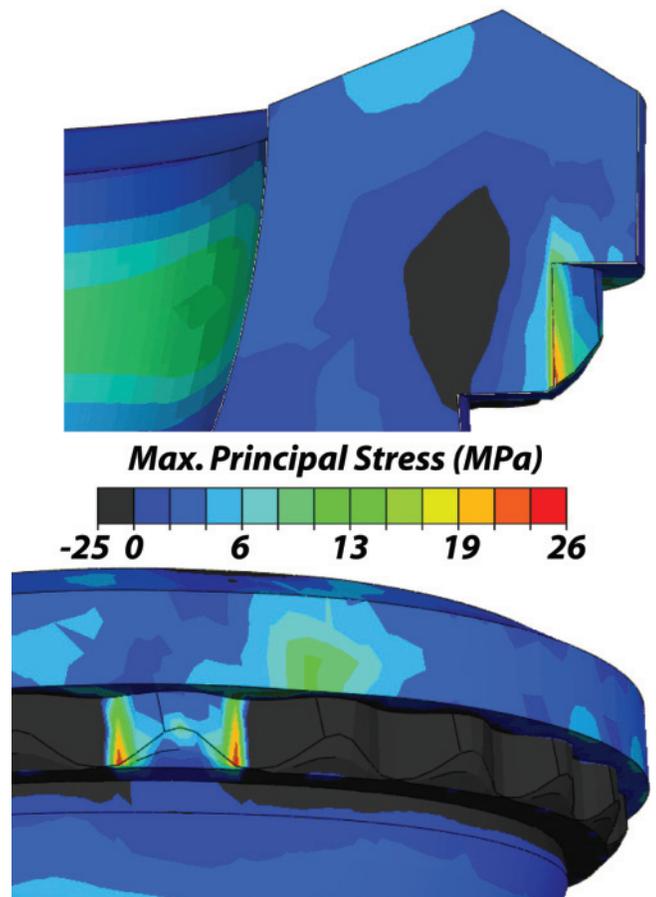
Figure 6. The stress during impingement is concentrated in exactly the same region seen in the observations (Figure 5). The stress in the cross-section is shallow, possibly explaining why failure was not catastrophic at this location.

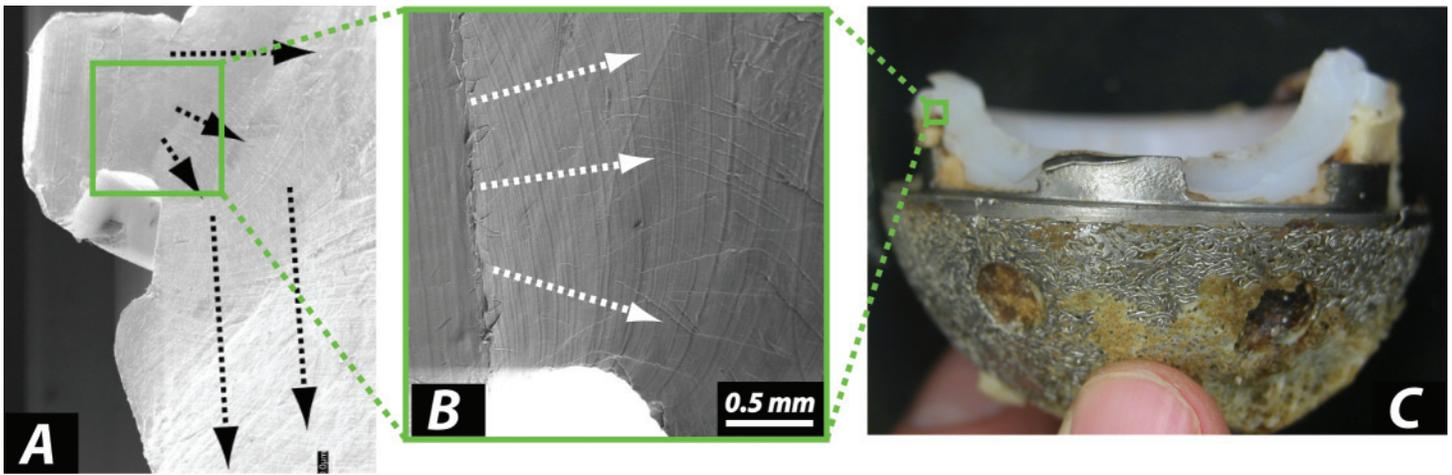
Figure 7. Fracture initiated at the corner of a slot cut into the rim (7A and B) and propagated in the characteristic crescent path. Note that this case used a crosslinked liner in a revision that did not match the metal shell height, resulting in a larger than normal amount of overhanging rim.

Case history A 74-year-old female with BMI of 21 had been treated previously for osteoarthritis of the hip with total hip arthroplasty when she was 60 years of age. A 54 mm Harris-Galante II acetabular component, 26 mm elevated rim acetabular liner, and cemented CPT stem (Sulzer, Austin, TX) were used. Vertical inclination of the cup was 51 degrees and anteversion was 8 degrees. Twelve years after primary THA she developed pain associated with subsidence of the femoral component and osteolysis. One year later, she fell and sustained a periprosthetic femur fracture. This was treated with revision to a 250 mm cemented Versys stem (Zimmer) and circlage fixation of the femur. The acetabular liner was worn, but the metal shell was well fixed and retained. A 32 mm Converge acetabular liner (Zimmer) was cemented into the metal shell. Two years after revision the patient experienced a posterior dislocation of the hip requiring closed reduction. Five months later while sitting in a chair she experienced another dislocation and revision THA was then performed. The rim of the acetabular liner was found to be fractured and the entire acetabular component was removed (Figure 7).

Findings This liner had the greatest amount of unsupported UHMWPE above the metal backing, nearly 10 mm in some locations, and thus experienced the greatest stress in this case series (36 MPa) during simulated impingement. It is important to note that the liner was fixed into a metal backing from a previous surgery that did not interface with the designed locking mechanism and necessitated bone cement for bonding during revision. This case shows that the height of the unsupported rim affects the stress during impingement, and that the interfacing of components may be more critical when employing crosslinked UHMWPE.

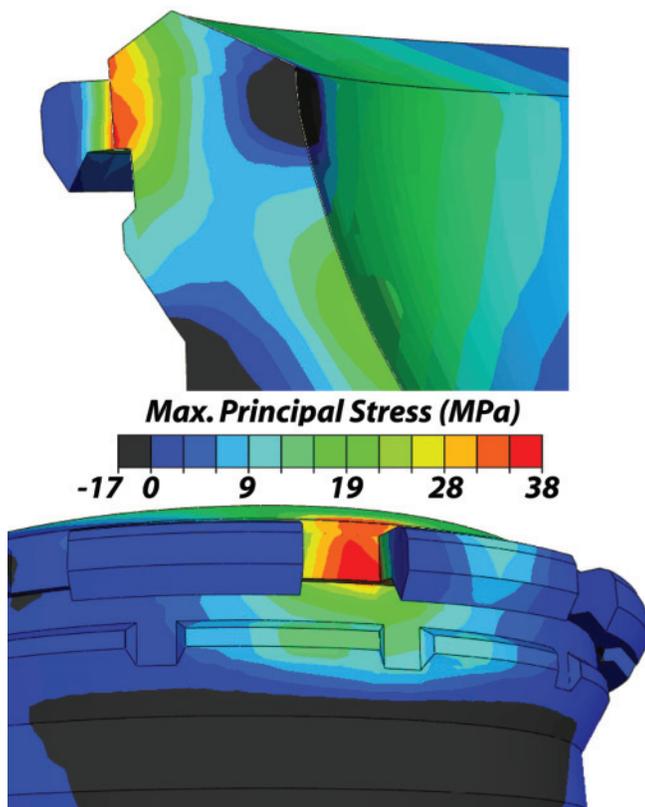
Figure 8. Predicted tensile stresses in this case are the greatest of the series, which is expected given the extent of exposed rim above the metal backing. Stress through the thickness is also high enough to readily drive fracture.

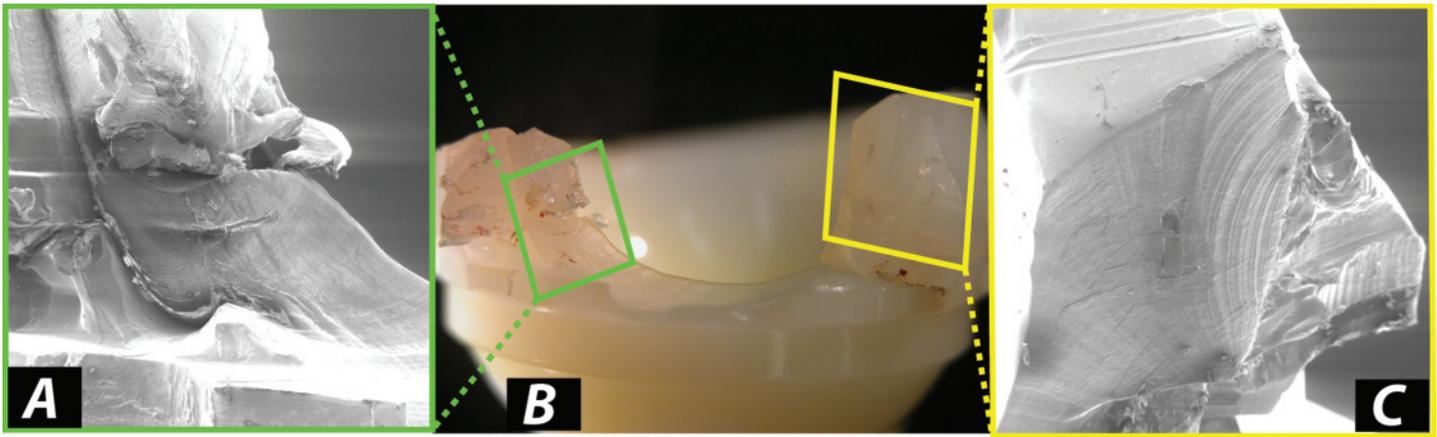
Figure 9. The sharp corners of milled slots in the rim initiate fractures, clearly shown in C. Multiple such fractures initiated independently. This case took the longest to fail, implying that while crack initiation was widespread, crack propagation was somehow limited.

Findings The predicted magnitude of stress is relatively low at 12 MPa, and agrees with the initiation location observed from fractography. The locking mechanism of this design has acute slots milled vertically in the rim, from which cracks can propagate. The corner of the slot appeared very acute upon microscopic inspection. Such a sharp corner may readily allow fatigue initiation, while the low stress experienced inside the liner would inhibit propagation. This liner employs a lower radiation dose (5 Mrad), which is known to yield improved fatigue performance [4]. This liner was in-vivo for the longest in the series, 5.4 years, which may have been enabled by the comparatively elevated fatigue properties of the moderately crosslinked UHMWPE and the relatively low stress during impingement.

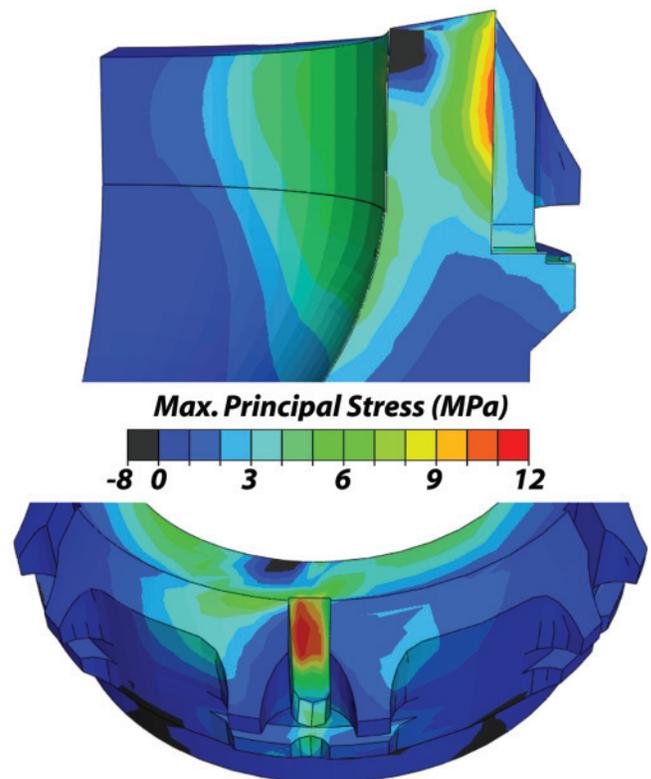
Figure 10. Tensile stress peaks at the observed initiation location, though it is the least severe of all implants in the series. The corner of the slot is the sharpest of the stress concentrations in the series, possibly explaining the ease of initiation that contrasts with inhibited propagation due to the overall low magnitude of tensile stress in the liner. The UHMWPE employed in this case is only moderately crosslinked, which may further frustrate crack propagation.

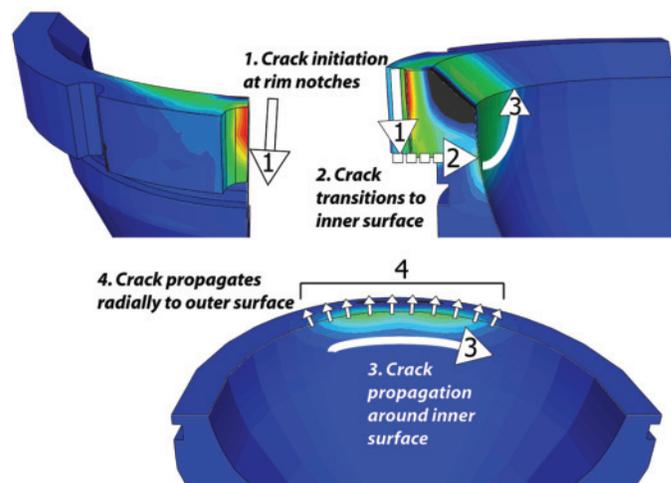
Figure 11. Schematic of crack advance, as inferred from the contours and orientation of tensile stress due to impingement. Note that Steps 2 and 4 are frustrated, as the tensile stress is low in the middle of the cross section and on the outside of the liner. Thus, arrested cracks may exist in intact implants outside of weight bearing region.
