FEMORAL NECK MODULARITY IN THA: NOT A BRIDGE TOO FAR?

A. Seth Greenwald, D.Phil.(Oxon)
Alon Katz, M.Sc.
Christine S. Heim, B.Sc.
Orthopaedic Research Laboratories
Cleveland, Ohio

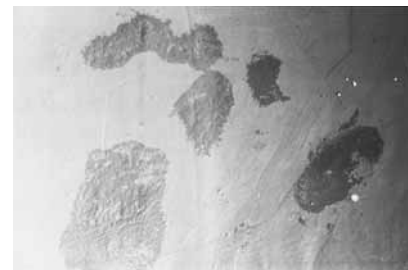
Scanning Electron Microscopy (SEM) displaying material loss on a metal-metal taper interface resulting from cyclic microdisplacements (x15 magnification)

The nature of modular hip systems is manifest through a series of interconnected metal-metal junctions involving the use of tapers. These are seen to be a structural weak link in comparison to their nonmodular counterparts due to surface damage resulting from microdisplacements at these interfaces under dynamic *in vivo* loading. This is referred to as fretting, which creates foci for crack initiation and is a first step in the sequela leading to component fracture. Component weakening may be further catalyzed through *in vivo* corrosion processes at these locations.

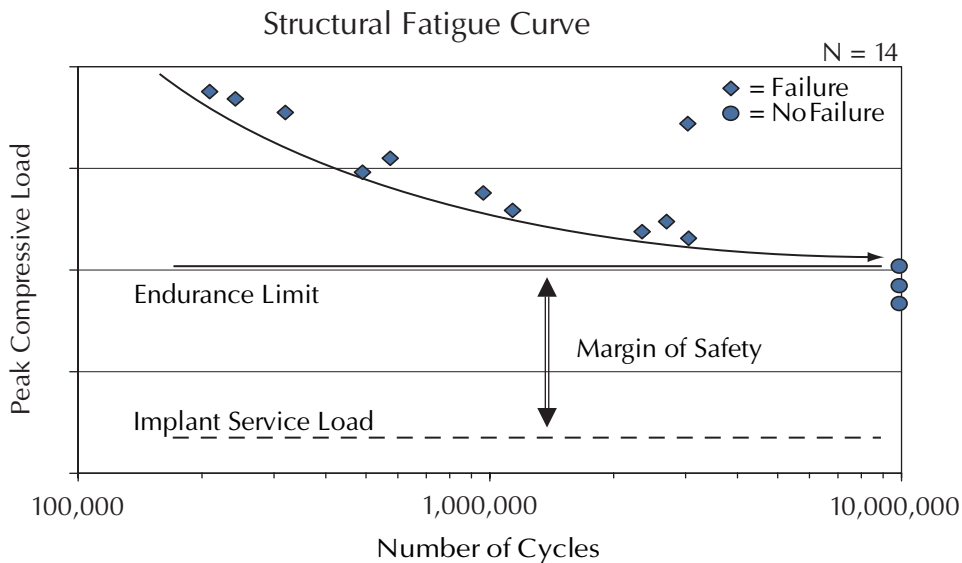
In the below idealized graph for a given design, the **endurance limit** defines the maximum cyclic load a modular femoral neck can support and theoretically never fail. For these studies, it is the largest load at which 10 million, uninterrupted cycles occur without device failure.

The **implant service load** is the maximum *in vivo* dynamic load on the hip during walking gait. Its value is dependent on variables of patient weight, walking speed and stride length.

The **margin of safety** is the difference between the endurance limit and the implant service load. When presented as a ratio, it represents a **safety factor** for a particular implant and serves as a predictor of implant structural integrity. Increasing patient body weight (BW) and activity level serve to increase the implant service load while the impact of fretting and corrosion decreases the endurance limit at modular connections.

$$\text{Safety Factor} = \frac{\text{Endurance Limit}}{\text{Implant Service Load}}$$

↑ BW & Activity Level = ↑ Implant Service Load
 ↑ Fretting & Corrosion = ↓ Endurance Limit

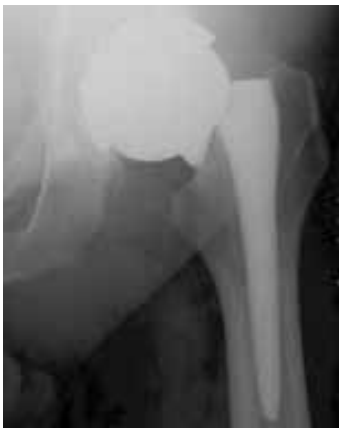
CASE 1 - A clinical example of a modular femoral neck, titanium alloy, primary system. Device fracture is observed at the neck/stem junction two months after a fall. This device survived in situ in this 340 lb patient 4 years before the trauma. The view of the stem/neck junction describes fretting and corrosion at the interface.²²

The above situations are clearly **functional** failures of the modular femoral neck implant chosen, subsequently requiring revision.

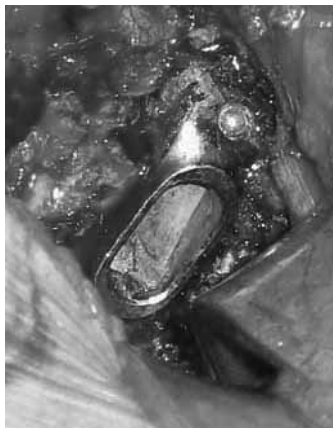
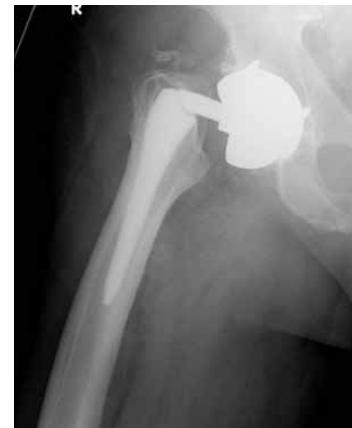
CASE 2 – A clinical example of a modular femoral neck, titanium alloy, primary system. Device fracture is observed at the neck/stem junction. A long varus neck coupled with a BMI of 34.2 and moderate activity contributed to device failure at 29 months in situ.
