NEW POLYS FOR OLD: *CONTRIBUTION OR CAVEAT?*

AMERICAN ACADEMY OF ORTHOPAEDIC SURGEONS

70th Annual Meeting

COMMITTEE ON BIOMEDICAL ENGINEERING COMMITTEE ON HIP AND KNEE ARTHRITIS

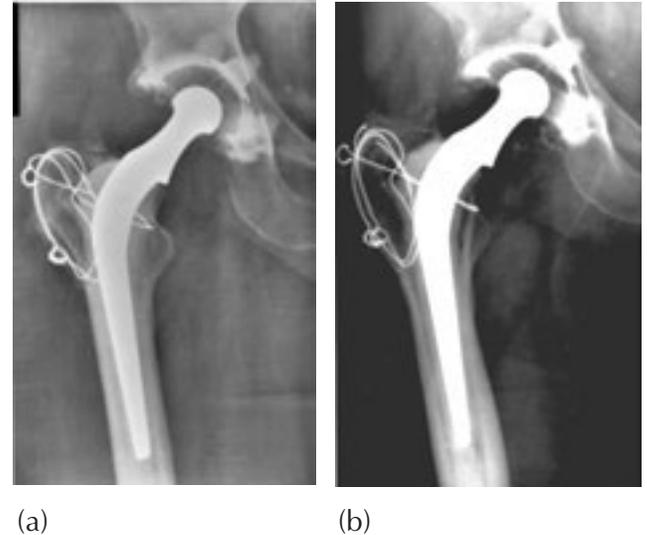
Figure 1: Radiographs of a Charnley cemented hip replacement. (a) immediate post-operative; (b) 25 years post-operative.

The enduring success of the low-friction arthroplasty first advanced by Sir John Charnley as a solution for severe hip arthritic problems may be appreciated from the fact that in 2001 more than 600,000 hip and knee arthroplasties were performed in the United States. The prevalence of aseptic loosening attributed to polyethylene debris-induced osteolysis has been in the single digits in most contemporary series, with some reports describing prostheses surviving for 20 to 30 years. (Figure 1)

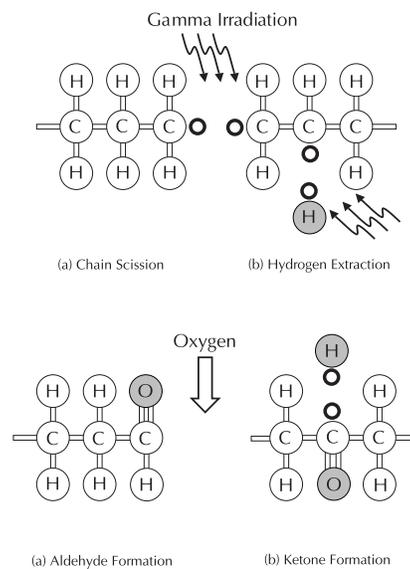
Figure 2: Depicted polymer chain breakage following irradiation in air and combination with oxygen facilitating oxidative degradation of UHMWPE.

The UHMWPE used in hip and knee components results from polymerization of ethylene gas into a fine resin powder of sub-micron and micron size distribution. It is consolidated with the use of ram-extrusion or compression-molding techniques. Structurally, the polymer is made up of repeating carbon-hydrogen ($-\text{CH}_2-$) units that are arranged in ordered (crystalline) and disordered (amorphous) regions. Irradiation to sterilize components breaks the polymer chains, creating free radicals, which in an air environment combine with oxygen, facilitating ongoing oxidative degradation of the polymer. (Figure 2)

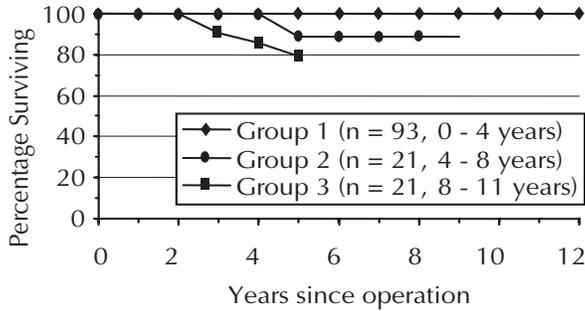
Figure 3: The influence of shelf storage on survival of a prosthetic knee plateau following gamma irradiation in air. From Bohl, et al., *Clin Orthop* 367:28-38, 1999.

Continued exposure of the component to oxygen through prolonged shelf storage in air before clinical use results in a progressive stiffening and embrittlement of the polymer, reducing wear resistance and fatigue strength. This is thought to represent a major contributing factor influencing *in vivo* polymer failure. (Figures 3 & 4)

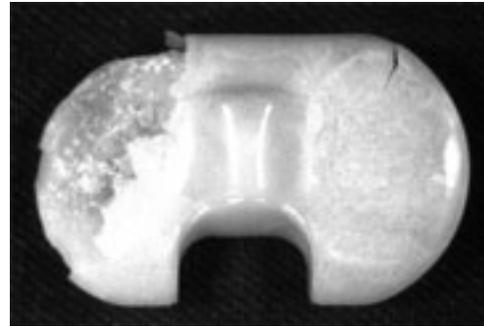
Figure 4: A Group 2 plateau implanted after 7.6 years of shelf storage and retrieved 3.8 years after implantation. Gross delamination and pitting, characteristics of fatigue failure, are observed.

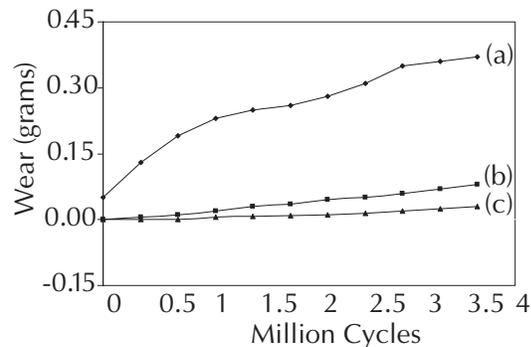
Figure 5: Hip simulator weight-loss comparison for aged (25 days at 78°C in O₂) compression-molded cup components. (a) irradiated in air; (b) sterilized with ethylene oxide; and (c) irradiated in a vacuum environment and use of barrier packaging. From Greer, et al., *Trans ORS* 23:52, 1998.

Alternative sterilization methods employing ethylene oxide or gas plasma without ionizing radiation avoid oxidation but do not realize potential wear performance benefits resulting from increased cross-linking. (Figure 5)

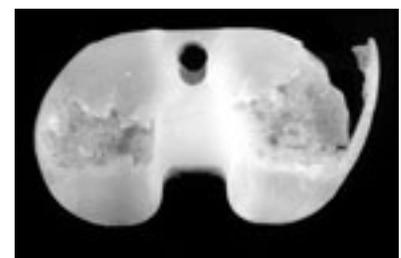
Figure 8: A heat pressed tibial component retrieved 6 years after implantation.

Heat pressing was yet another attempt to improve the finish of the articular surface, but was associated with polymer fatigue and early delamination. (Figure 8)

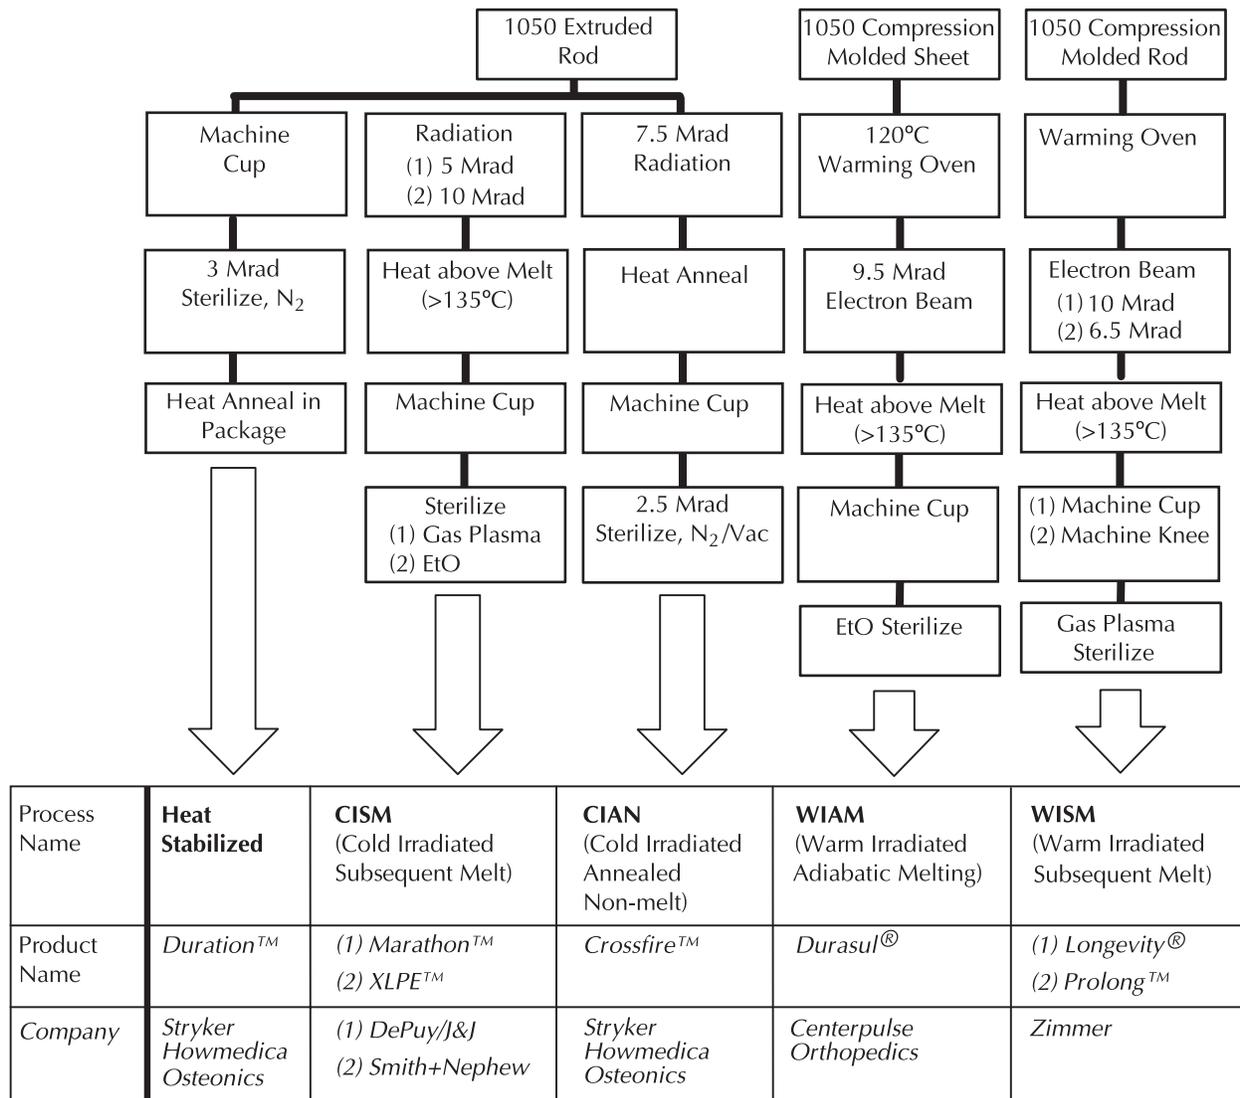
Figure 9: Current methods used to manufacture moderately to highly cross-linked polyethylene.

Process differences include: 1) heating above or below the melt temperature of the polyethylene, 2) the radiation source, 3) dose level and 4) end-point sterilization. (Figure 9)

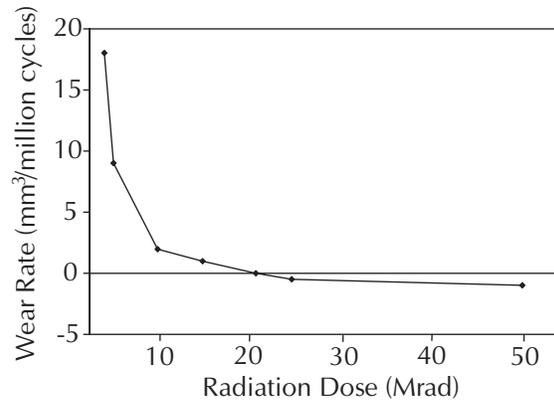
Figure 10: Mean acetabular cup wear rates versus gamma dose level. From McKellop, et al., *J Orthop Res* 17:160, 1999.

In general, increasing the radiation dose dramatically reduces polymer wear in laboratory hip joint simulation. (Figure 10) Free-radical suppression through kinetic recombination at increased temperature in an oxygen-free environment or quenching through remelting represent efforts to stem the oxidation process.

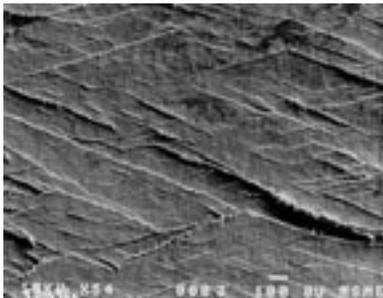
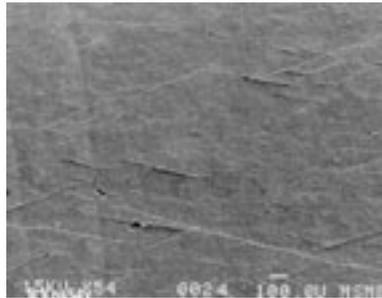
Figure 11: SEMs of UHMWPE fatigue fracture specimens. (a) gas-plasma-sterilized specimen demonstrating ductile tearing associated with plastic deformation and slowing fatigue crack growth; (b) radiation cross-linked specimen demonstrating the relative absence of ductile tearing mechanisms. From Pruitt, et al., *J Biomed Mater Res*, 46: 573-581, 1999.

There is laboratory evidence to suggest that processing methods utilized to increase cross-linking decrease resistance to fatigue crack propagation (Figure 11), a finding that could have implications for modular acetabular cup designs (Figure 12) as well as the suitability of highly cross-linked materials in knee application.

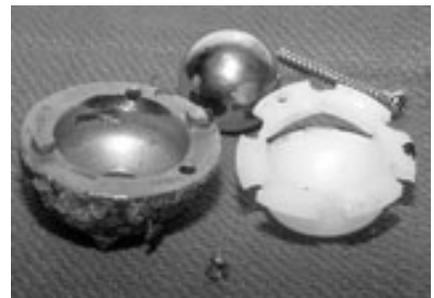
Figure 12: Crack propagation failure of a retrieved conventional polyethylene liner associated with an inadequate locking mechanism design.

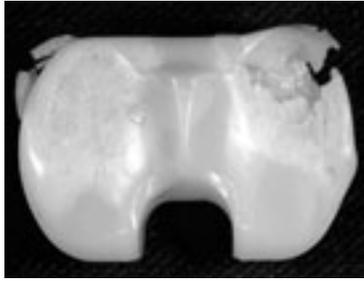
Figure 13: *A retrieved conventional UHMWPE tibial insert demonstrating typical knee failure patterns of gross delamination and pitting.*

It is important to appreciate that the prevalent modes of hip and knee material damage differ. While abrasion and adhesion are the most important mechanisms of hip wear, fatigue-induced delamination and pitting predominate in the knee, a reality universally appreciated in clinical retrievals. (Figure 13)

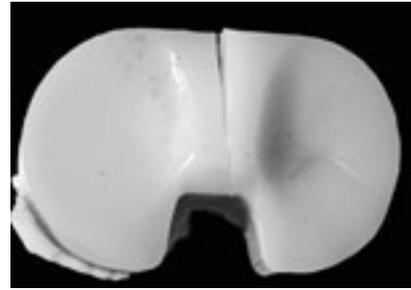
Figure 14: *A retrieved conventional UHMWPE tibial insert demonstrating an anterior-posterior fracture of the non-articulating portion of the insert.*

Additionally, reduced fracture properties in highly cross-linked polyethylenes raise concerns of gross fracture in knee components, a condition relatively rare with conventional UHMWPE. (Figure 14)
